ISPITIVANJE I KONTROLA KVALITETE SVJETLOVODNIH MREŽA

FIBRE OPTIC NETWORKS TESTING AND QUALITY CONTROL

Krešimir Osman¹, Luka Majdandžić², Trpimir Alajbeg¹

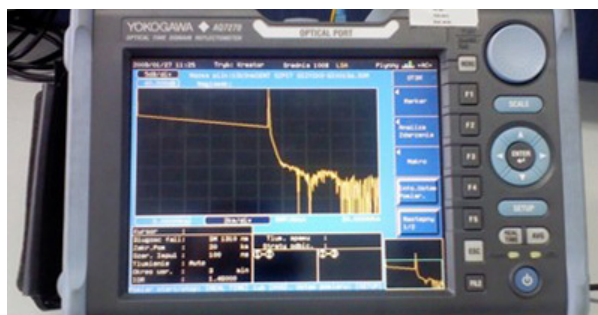
An Optical Time-Domain Reflectometer (OTDR) (Figure 1) [13] provides a detailed insight into attenuation variations along the entire length of the fibre, enabling the precise location of problems such as micro-cracks or poor splices. Reflection measurements are typically performed using this device, which allows for accurate identification of points in the network where signal reflection occurs. The device operates by emitting light pulses through the fibre and measuring the amount of reflected signal along its length. This enables precise identification of critical reflection points and the implementation of necessary corrective measures to reduce their severity. In addition, the OTDR is commonly used to measure fibre length, as it emits a light pulse through the fibre and measures the time required for the reflected signal to return. Based on this data, it can accurately calculate the fibre length and detect potential irregularities such as fibre breaks or poor splices. A Yokogawa AQ7270 device was used for the measurements (Figure 1). OTDR traces display losses and reflections along the optical fibre, allowing for precise localization of network problems such as poor splices or defects. By analysing the OTDR trace, engineers can visualise points of signal loss and quickly identify and resolve faults. Attenuation measurement is a fundamental measurement and is often sufficient for relatively short optical fibre networks (up to several kilometres). However, on long routes (several tens of kilometres) and on routes where Dense Wavelength Division Multiplexing (DWDM) systems are used, it is often necessary to perform dispersion measurements (chromatic, non-chromatic, and polarisation).

Figure 1 Front panel of the OTDR measurement device

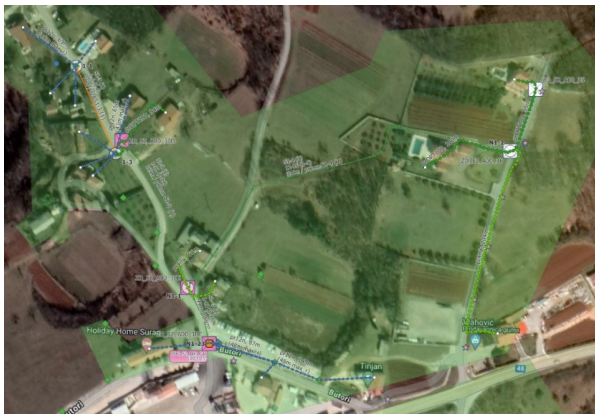
The analysed optical fibre network (Figure 2) consists of several components that enable a reliable and high-quality transmission infrastructure. Special attention was paid to the routing and placement of the individual cables to avoid additional costs. The network was designed with the primary goal of ensuring optimal connectivity between the distribution node, business offices and the end user, using modern fibre optic technologies and the ©GIS software tool.

Figure 2 Visualization of designed fibre optic network in the ©GIS software tool

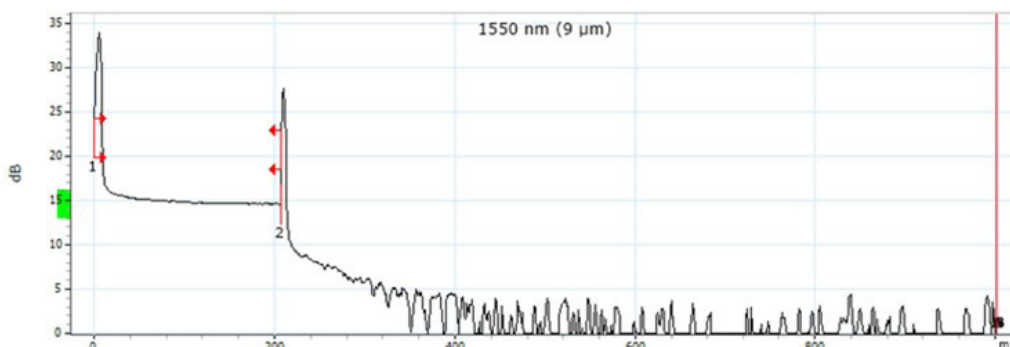
Based on the provided OTDR report for thread nr. 12 of the underground splice points, the measurement indicates a break-related problem at a wavelength of 1550 nm. The total fibre length is 207.7 m, with an average signal loss (attenuation) of 0.003 dB/m and a total loss of 0.689 dB across the entire fibre length. According to the OTDR diagram report (Figure 5), a break is present in the thread.

This break was detected at a distance of 207.7 metres, suggesting a significant problem at that location caused by a damaged fibre or a faulty splice. According to the diagram in Figure 5, the first reflection (point 1) occurs at the OTDR connector (beginning of the fibre) and has a level of about 33 dB. The second reflection (point 2) is a splice or connector at 207.7 m. After point 2, a drop from 15 dB to about 5 dB (discontinuity) is visible. The value of -41.2 dB is not shown on the diagram, as it is a back-reflected signal (reflectance).

Possible causes of the fault:

- Damaged fibre: indicating possible physical damage to the fibre, such as a tear or bend that prevents normal signal transmission.
- Mechanical stress: optical fibre may have been subjected to mechanical strain, such as excessive tension, which may cause a break or macro bending.

Figure 5 OTDR diagram indicate a fibre break on thread number 12

Remedial action:

- Visual inspection: A visual inspection should be carried out at the location of the break to

identify any physical irregularities or damage to the fibre.

- Replacement of the damaged segment: If the fibre is physically damaged, the affected section of the cable must be replaced with a new one.
- Retesting: After the repair has been completed, an OTDR measurement should be repeated to verify the quality of the splice connection and ensure that no additional losses or reflections occur.

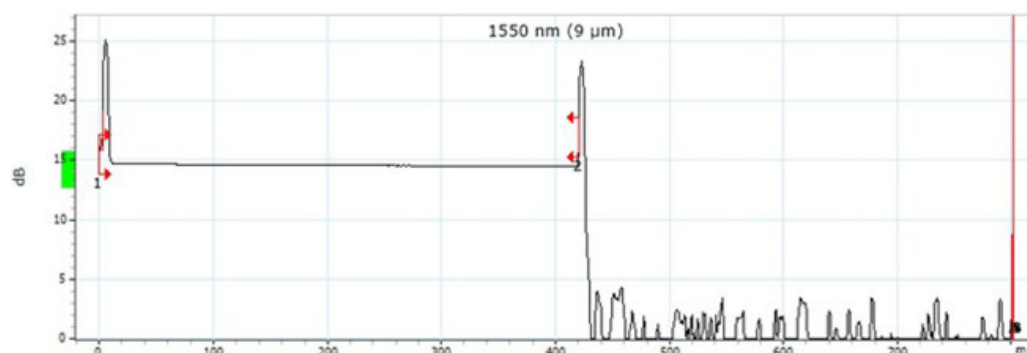
After the corrective measures were implemented, the new OTDR diagram for thread nr. 12 is shown (Figure 6):

- Elimination of reflections: No reflections are observed at previously problematic locations, indicating that the splices have been properly executed and no longer cause back-reflections that could interfere with the signal.
- Uniform signal trace: The signal line is now smooth and continuous, without abrupt drops, indicating stable data transmission throughout the entire fibre length.

- Fibre length: 420.6 m,
- Average loss attenuation: 0 dB/m,
- Total signal loss: 0.203 dB.

Following the replacement of the affected segment, the line is stable and free of reflections, indicating a clean and consistent signal path that ensures high transmission reliability and speed. The resolved issues reduce the need for further interventions, thereby lowering maintenance costs and extending the infrastructure's operational lifespan. Regular monitoring is recommended to ensure that the quality remains consistent over time. Fibre 12 is now fully operational and ready for use.

Figure 6 OTDR diagram for thread nr. 12 after corrections

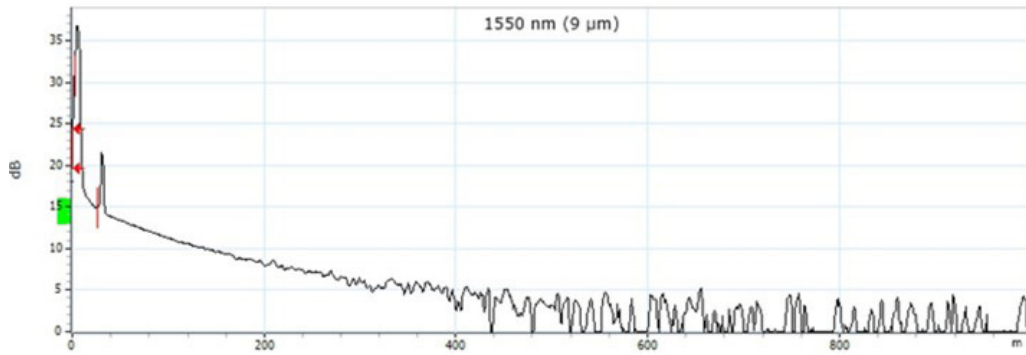
Based on the OTDR report for thread nr. 9 in the network, the measurement indicates significant signal disruption occurring at the beginning of the fibre. The diagram shows a sharp signal drop (Figure 7), which indicates a physical break in the fibre or an improperly executed connection at the panel. According to the obtained results, it is evident that the fibre is non-operational, which may result in a complete loss of communication for all devices connected through this link.

- Fibre length: 1000.4 m (due to a damaged panel),
- Splice loss: 0.00 dB,
- Reflection: > -25 dB,
- Average loss: unknown.

The problem with this strand originates from a break at the panel, which can be caused by various factors, including:

Figure 7 OTDR diagram for thread nr. 9 indicating a break at the panel

The fault most likely occurred due to an improper connection at the control panel or damage sustained during installation or maintenance. If the connector is not properly connected or if the fibre is broken inside the connector, the signal cannot pass smoothly through the fibre, resulting in a break.

Remedial measures to resolve the fault:

- Visual inspection: It is necessary to perform a visual inspection of the connector at the panel to determine whether there is any physical damage or improper connection.
- Connector cleaning: If contamination is detected, the connector should be cleaned using special connector cleaning tools.
- Reconnection: In a case of improper mating, the connector should be connected correctly,

ensuring proper alignment of the optical fibres.

- Damaged component replacement: If the fibre or connector is found to be damaged, replace the affected component to restore proper signal transmission.
